Remediation of landslides on railway line between Karlovac and Mrzlo Polje stations

Professional paper

Dalibor Udovič, Ivan Igrec, Mario Bačić, Meho Saša Kovačević

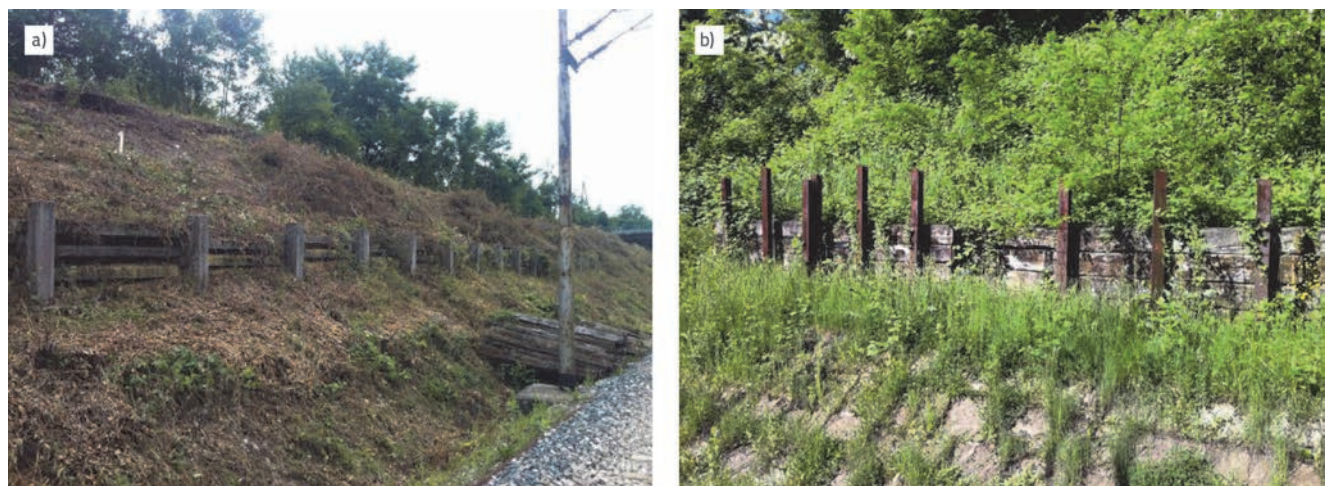
However, most parts of the section were affected by landslides that formed on cutting slopes a short time after the end of construction work. Thus, eight year after the railway was built, i.e. in 1975, the remedial work, involving RC piles and prefabricated walls, was carried out on five locations. Other five locations along the said section, where the landslide occurred at a later time, were remediated by makeshift remedial measures including foundation soil removal, and construction of a temporary protection wall formed of rails and wooden sleepers. These local remedial actions are presented in Figure 1.

Figure 1. Remediation by: a) prefabricated concrete wall; b) wall made of driven rails and wooden sleepers

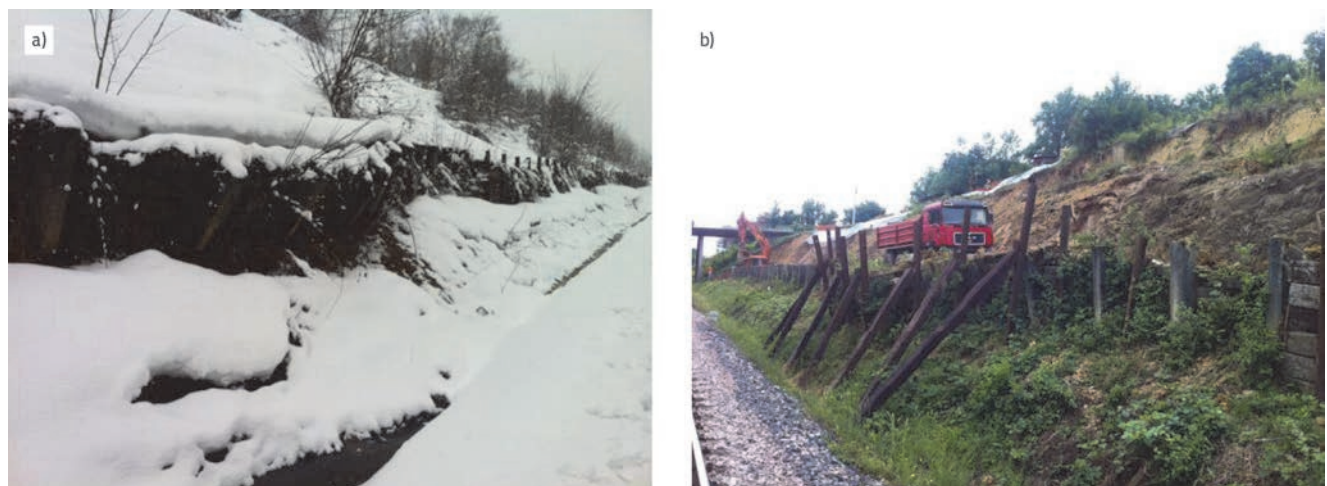
However, before completion of the detailed design documents, in the early 2013, the sliding action intensified to such an extent that the functionality and safety of the railway section and the private property units on the platform above the cutting were gravely imperilled. The landslide activity increased following the period marked by intense precipitation, i.e. heavy rain and snow. The combined action of intensive precipitation and saturation of the surface layer with waste water generated in the nearby housing units situated near the crown of the slope, called for urgent remedial activity. The completely deformed prefabricated concrete wall is shown in Figure 2.a. In order to temporarily stop further degradation, various improvised protection measures were implemented, such as the ones presented in Figure 2.b, involving 8 driven rails supporting makeshift protection elements.

Figure 2. Degradation of implemented remediation measures: a) completely deformed prefabricated concrete wall; b) makeshift slope protection structure

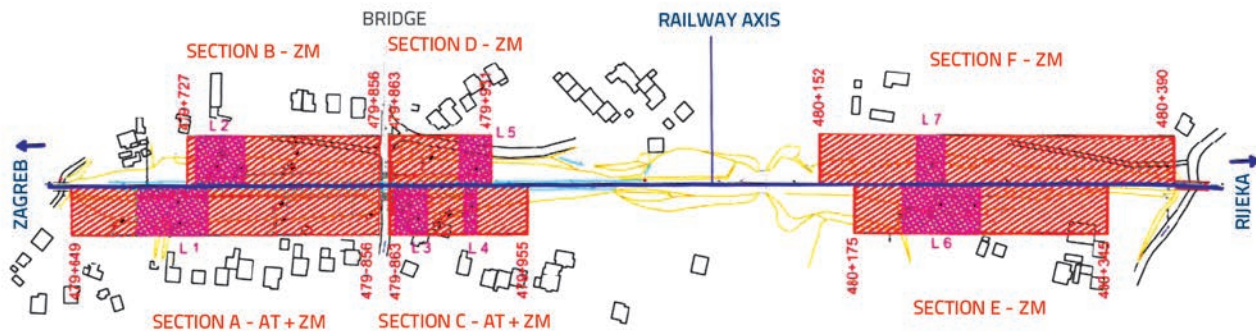
Figure 3. Remedial work status (AT – reinforced earth wall; ZM – material replacement)

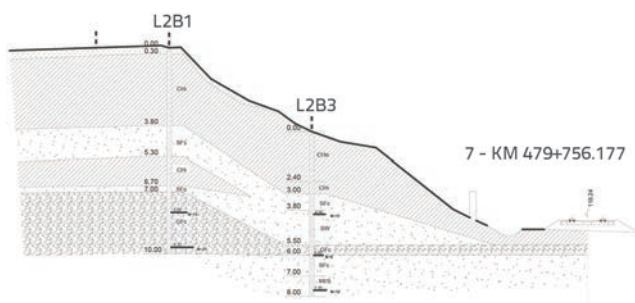
Under the said clay layer, fine-grained densely compacted gravels, with an excessive quantity of clay or silt, alternate with compacted sand layers, also with an excessive quantity of silt or clay, while thin intercalations of described clay formations can also locally be observed (Section D). A typical engineering geological section for Section B is shown in Figure 4.

Figure 4. Typical engineering-geological section for Section B

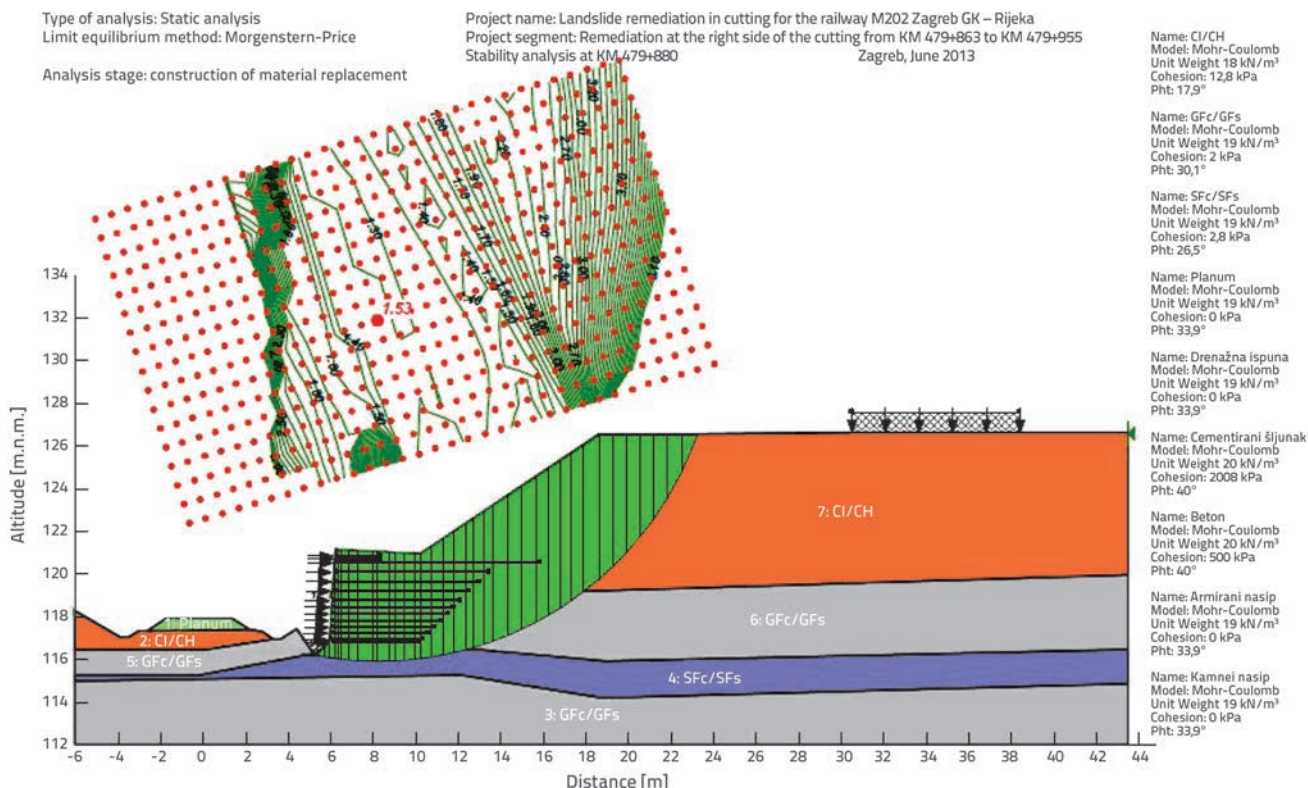
Figure 5. Stability analysis results after reinforced earth wall construction and material replacement ($F_s = 1.53 > F_{s,min} = 1.00$)

All analyses comply with the minimum safety factor of 1.0, and one of calculation results (global stability analysis after the reinforced earth wall and soil replacement construction) is shown in Figure 5. The selected typical cross section of remediation at Section C is shown in Figure 6.

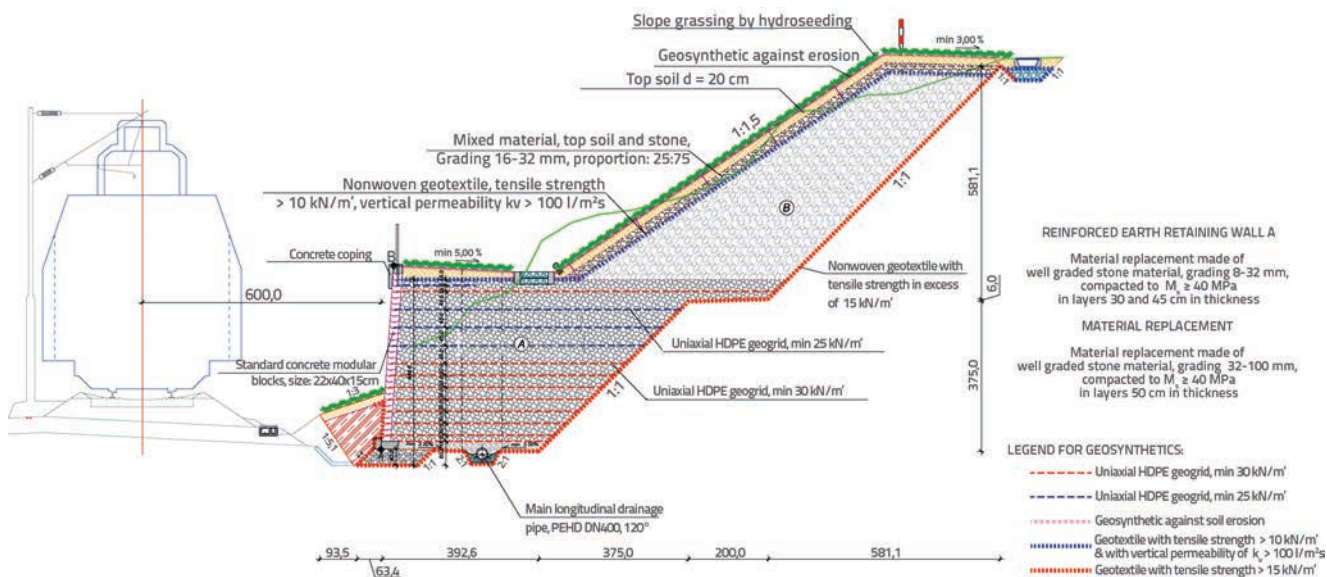
Figure 6. Typical cross section of remediation measures at Section A

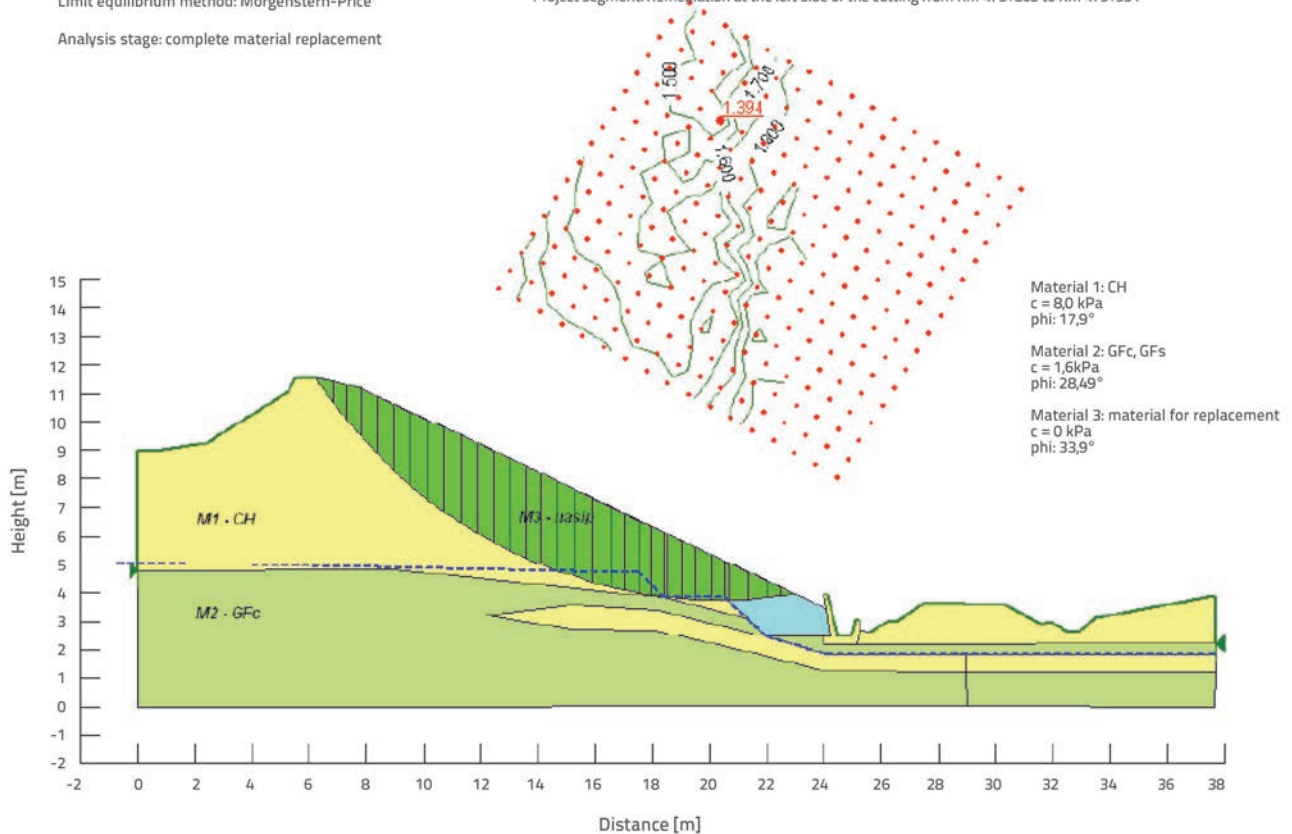
Figure 7. Stability analysis results after replacement of material ($F_s=1.39 > F_{s,min}=1.00$)

Static analyses were conducted for each individual construction stage, while the analysis of seismic influence on the stability of the newly formed slope was carried out for the final stage. All analyses complied with the minimum safety factor of 1.0. One of the calculation results (after material replacement at the top part of slope) is shown in Figure 7. The selected typical cross-section of remediation measures at Section D is shown in Figure 8.

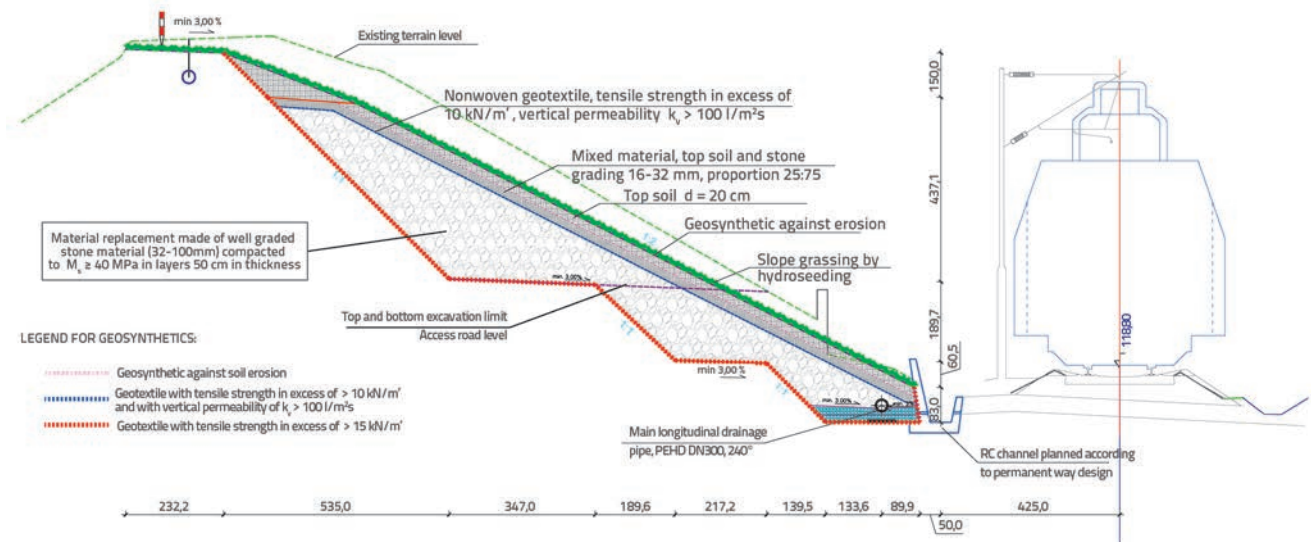
Figure 8. Typical cross-section of remediation measures at Section D

At other parts of the route, the remedial work is finished (Section B and Section D), or is to be conducted (Section E and Section F) by material replacement, as proposed in the preliminary design. However, the solution (Figure 8) has been adapted to new geotechnical analyses, to the planned technical implementation of the solution, and to the future permanent way design (planning of drainage to be connected with the drainage system via channel elements, according to the permanent way remediation design) "New double track combined-transport railway line M202, Goljak – Karlovac – Skradnik".

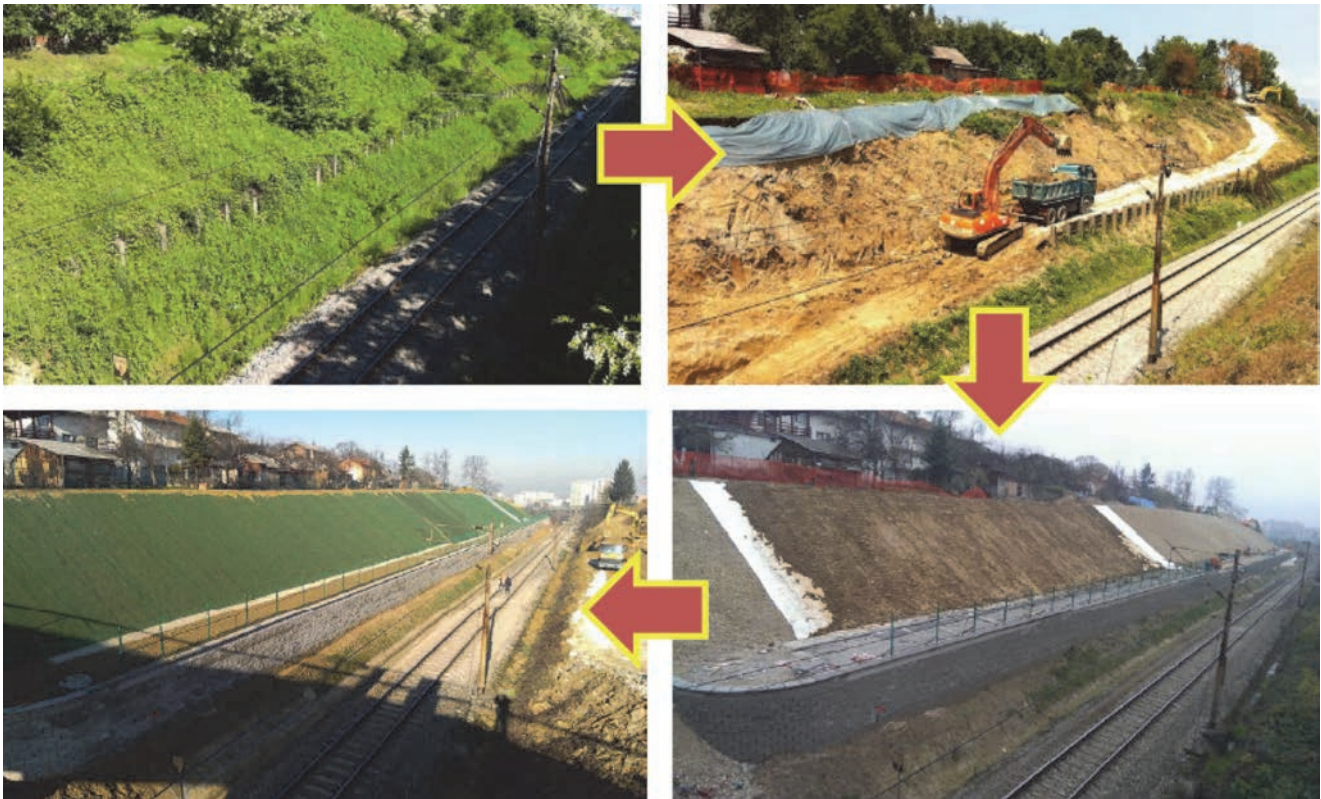
Figure 9. Landslide remediation at Section A

After excavation for reinforced earth wall, the foundation soil was compacted so as to achieve favourable physicomaterial properties. Then the non-woven geotextile (15 kN/m' in tensile strength) was placed onto the soil compacted in this way. At its plane, the geotextile also assumed the role of a drainage medium, i.e. it conducted the seepage water to the perforated pipe situated at the bottom of the reinforced earth wall. This was followed by construction of the footing using stone material and cement, and by construction of the drainage ditch in which a perforated pipe PEHD DN400, 120° was placed. After this, the construction continued with realization of the reinforced earth wall, i.e. with placement of geogrids, backfilling of stone material 30 cm in thickness, and its compaction to 40 MPa. The reinforced earth wall consisted of modular concrete blocks (without any load carrying function), polymeric connectors, and geogrids. The geogrid was placed onto cleaned blocks via a groove in the block, and each end of the geogrids was connected with the connector, which provided for a proper link between the geogrids and modular concrete blocks. Geogrids 2 m in length were installed at the top of the wall (final two modular blocks) in order to ensure stability at the wall crown level. The concrete coping was placed on top of the final modular block, and this coping was fixed with anchor to modular blocks. Geogrids manufactured by Tema Xgrid 60/30 kN/m' were used. The construction was realized in sections 20 m in width.

A surface drain was installed at the top of the wall, and its stability was ensured by a peripheral channel with transverse beams. A special attention was paid to the installation of manholes that are situated within the reinforced earth walls, and to the placement of geogrids around the manholes. The wall construction was followed by realization of the material replacement, which was made in layers 50 cm in thickness, with compaction of each layer to 40 MPa. This was followed by placement of geotextile 10 kN/m' in tensile strength, and 100 l/m²s in vertical permeability. The activity continued by placement of mixed material (stone and top soil 25 cm in thickness, with compaction to 30 MPa), placement of top soil 20 cm in thickness, placement of geosynthetic material against erosion KMat, and by slope hydroseeding. The peripheral drainage by means of concrete channels was made on top of the slope. As the existing cables were situated at approximately 1.5 m from the channel axis, a special attention was paid during excavation work at the top of the slope. Individual remediation stages at Section A are shown in Figure 9.

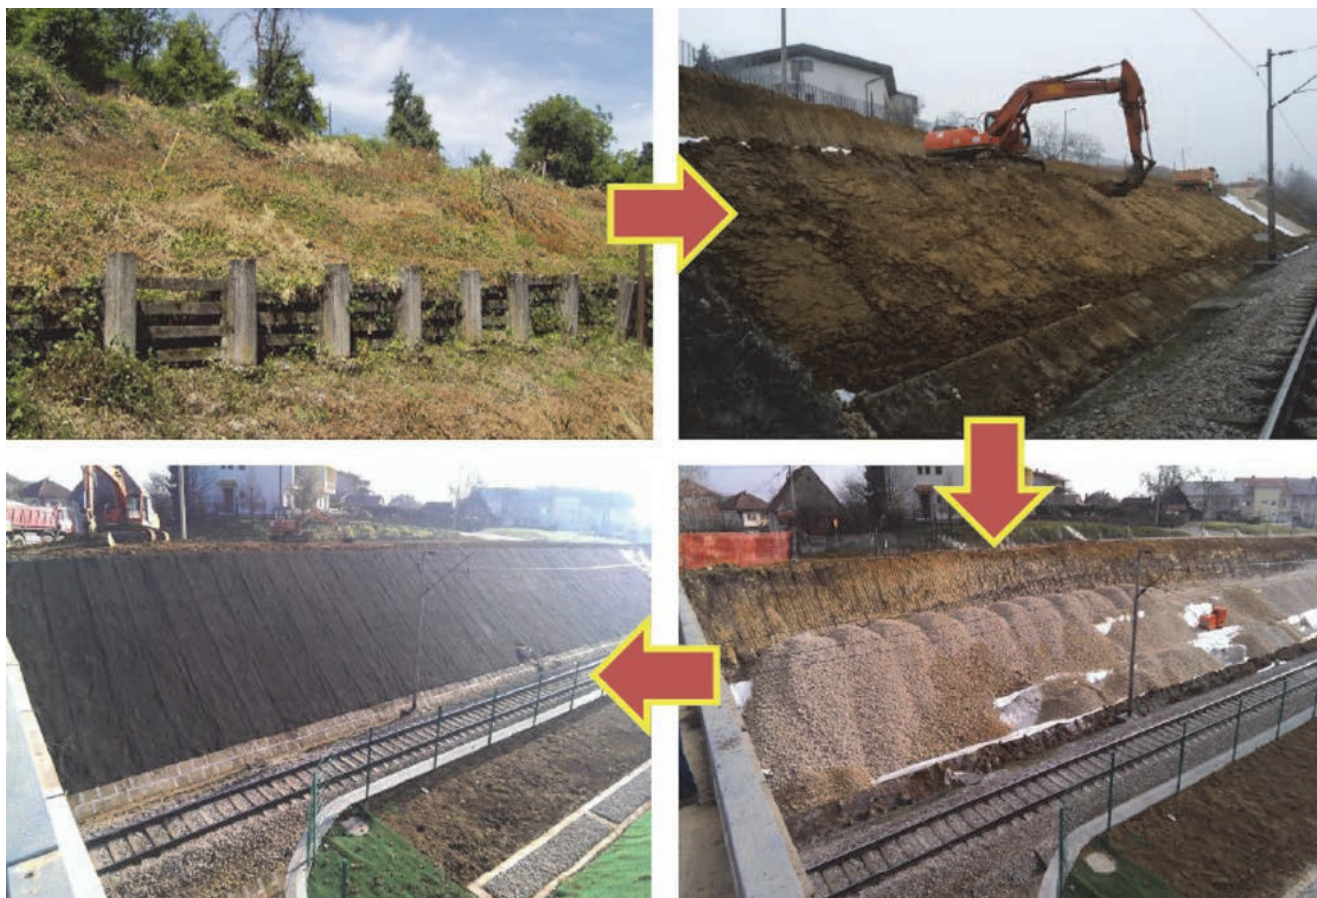
Figure 10. Landslide remediation at Section D

As approach roads at sections B and D fully passed through softer coherent material layers, the geotextile was placed on the road subgrade, and the compacted stone material 30 cm in thickness (with grading similar to that used for replacement) was placed on that geotextile. In longitudinal direction, the access road followed the grade of the railway and, in transverse direction, it presented the cross slope of 5 % toward the railway. The axis of approach roads was situated, throughout the length of these roads, at about 2.05 m above the railway axis. The work had to be divided into the top and bottom parts because of the overall height of the work and soil characteristics. The work was conducted in sections 20 m in width. However, a special care was paid during channel excavation at the bottom part, where maximum width of sections amounted to 5 m. After the full excavation in a particular segment, and prior to construction of replacement, perforated drainage pipes (PEHD DN300, 240°) were placed onto the cemented stone material bedding covered with geotextile. These pipes were connected via appropriate connections with the new concrete channel. The drainage slope amounted to 0.5 % out of which 0.3 % follows the slope of the railway axis (i.e. the fall of the channel axis),

while an additional 0.2 % was obtained by varying the depth of the bedding under the drainage pipe. Before construction, the entire face of the excavation was covered with geotextile, which was placed onto the previously compacted subgrade, and which carried the seepage water to perforated pipes at the toe of the slope. Because of vicinity of the existing underground cables, the works on top of the slope were carried out with utmost care, and even by hand, when necessary. The material replacement was made of well graded stone material, with the grain size ranging from 32 to 100 mm, placed in layers 50 cm in height, with compaction of each layer to the stiffness modulus of $M_s > 40$ MPa. The inclination of the finished slope was 1:2 in the entire work zone. The realization of the entire material replacement was followed by placement of the geotextile with the tensile strength of 10 kN/m', and with the vertical permeability of 100 l/m²s. This was followed by placement of mixed material (stone and top soil) 25 cm in thickness, with compaction to the stiffness of 30 MPa, The work continued with placement of pure top soil 20 cm in thickness, laying of geosynthetic material (erosion prevention), and with slope hydroseeding. Individual remediation stages at Section D are shown in Figure 10. The quality of works, i.e. the quality of compaction (stiffness) of layers, was checked by bearing plate (contractor's tests), and
