# Capacity degradation and crack pattern development in a multi-storey unreinforced masonry building

A seismic assessment of a typical unreinforced masonry residential building without tie beams is presented in the paper. The numerical analysis was conducted according to the finite-element method using experimental data on the quality of the masonry constitutive elements and reinforced concrete. The computation was made using the nonlinear static pushover analysis and nonlinear dynamic time history analysis. The crack development pattern was compared for the procedures, as well as parts of the hysteresis curves.

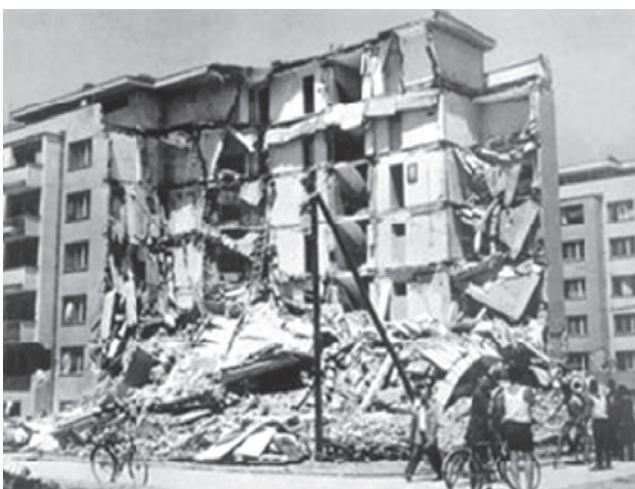
Figure 1. Destroyed residential masonry building (five storeys) [3]

floor due to a remarkable change in stiffness. The observed damage and collapse can be related to the building illustrated in Figure 1 after the Skopje earthquake. It is evident that this type of structures, typical for the entire region, is unable to withstand an earthquake of such a high ground acceleration. Parts of hysteresis curves for all three cases, and the capacity curve for the pushover analysis, are shown in Figure 23. As can

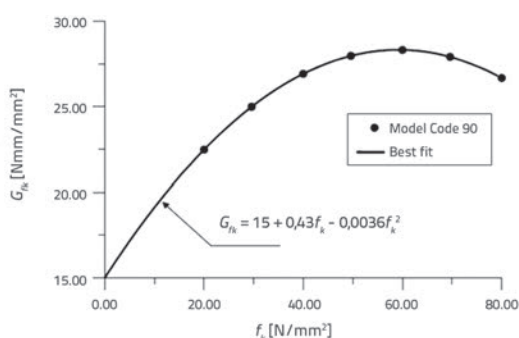
and, for brick, it has a recommended value of 0.029 mm [10]. The determination of the compressive fracture energy is also based on the Model Code 90 [9] for the peak strain of 0.2 %, as shown in Figure 2.

Figure 2. Compressive fracture energy according to Model Code 90 [9]

The applicability of this curve varies from 12 to  $80 \text{ N/mm}^2$ , and it is calculated from the equation (6):

$$G_{rk} = 15 + 0,43 \cdot f_k - 0,0036 \cdot f_k^2 \text{ [N/mm]} \quad (6)$$

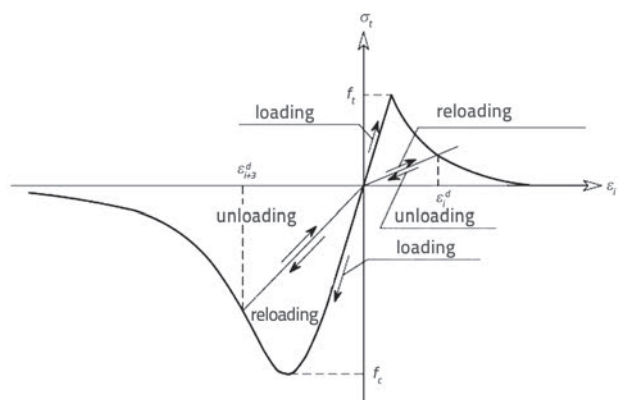
A parabolic stress-strain relation for compression, based on the Hill-type yield criterion, was chosen for nonlinear behaviour of masonry, with no lateral confinement and no lateral crack reduction. The tension path, based on the Rankine-type yield criterion, was described by an exponential tension-softening diagram. The post-cracked shear behaviour was defined by taking into account the retention factor of its linear behaviour, the shear retention factor,  $\beta = 0.01$ . More details are provided in [11-13]. This material nonlinearity is presented in Figure 3.

Figure 3. Nonlinear behaviour of masonry [14]

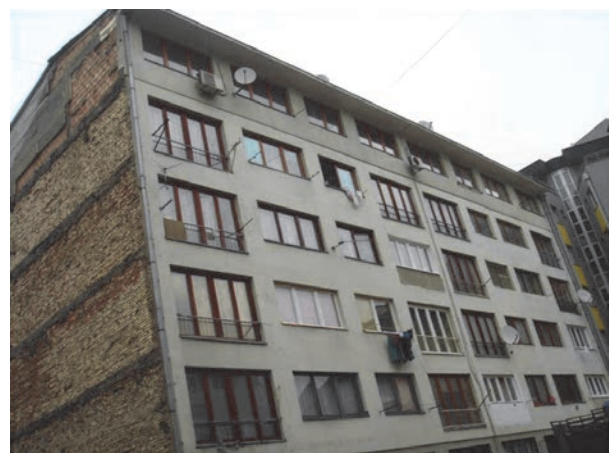
The typical residential masonry building analysed in the paper is located in Sarajevo, in the part of the city called Grbavica (Figure 4).

Figure 4. Analysed building built in 1957

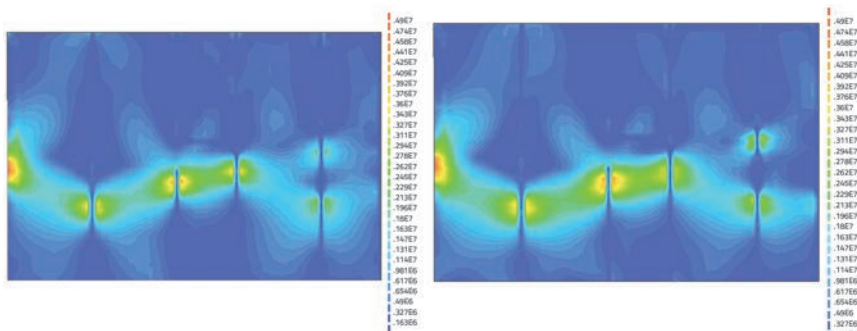
Figure 7. Tensile stresses in slabs of 1<sup>st</sup> and 2<sup>nd</sup> floors, at the final stage

The linear static analysis was conducted to check the reactions, stresses, strains, displacements due to self weight of the structure, and the structure's overall behaviour. As indicated in Section 3, the floors were modelled as linear elastic elements, and the analysis was made to check whether principal stresses in the floors are lower than the tensile strength. As can be seen in Figure 7, the major part of the slab has the tensile stress of less than 2.2 MPa, with few peaks at the locations of the walls, which is due to the compatibility conditions.

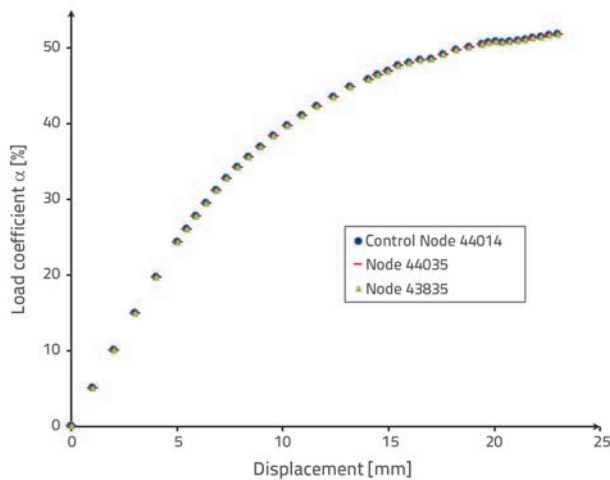
Node movements at the top of the structure along the same horizontal line (43935, 44035 and 44014), as shown in Figure 9, were investigated in order to prove the rigid-floors assumption. As illustrated in Figure 11, the movements of these nodes were the same, which shows that the slab behaviour is rigid.

Figure 9. Capacity curves for nodes 44014, 44035, and 43935

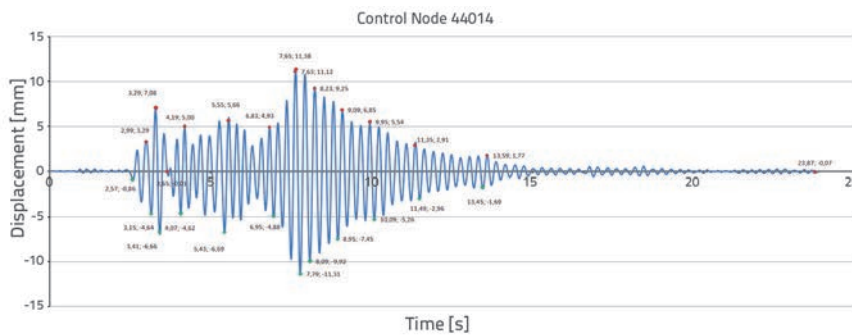
Figure 13. Horizontal displacement of control node 44014 as related to time

In order to view the development of damage to the structure during an earthquake, it was necessary to investigate the damage pattern (principal tensile strain distribution) in different time steps. The displacement vs. time of the Control Node 44014 (as in the pushover analysis) was chosen and plotted as shown in Figure 13. The maximum displacement amounts to  $-11.38$  mm at the time of 7.65 s.

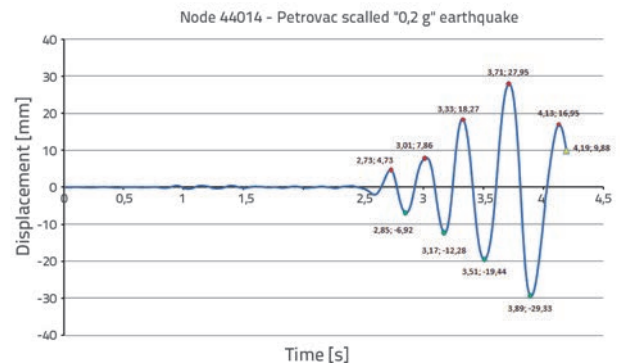
of  $a_g = 0.2 \text{ g}$ . Time-related displacement of the control node 44014 is shown in Figure 19.

Figure 19. Horizontal displacement of control node 44014

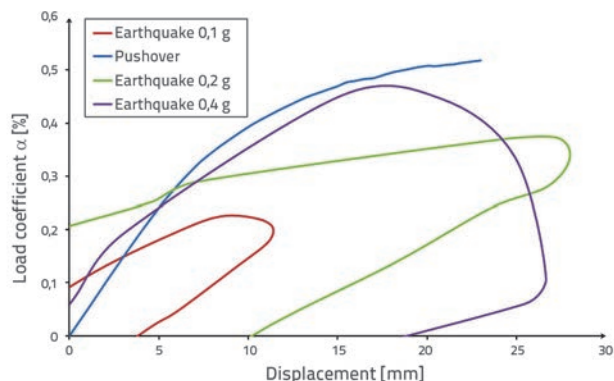
Figure 23. Parts of hysteresis curves and capacity curve

be seen, relatively small displacements can be observed for the structure subjected to the earthquake action of  $a_g = 0.10$  g. It is evident that the significant damage and energy dissipation can be observed when the ground acceleration equals  $a_g = 0.20$  g, while the entire capacity of the structure is exhausted for the real Petrovac earthquake. It is important to mention that an unacceptable inter-story drift amounting to 5.77% was observed during the earthquake action with the ground acceleration of  $a_g = 0.20$  g, and so the building can not be considered safe for this earthquake action [11, 12].
